5700A/AN Failure Analysis

Kevin Abercrombie
Naval Air Warfare Center, Aircraft Division
Patuxent River, MD

NCSLI Workshop & Symposium July 29 - August 2, 2001

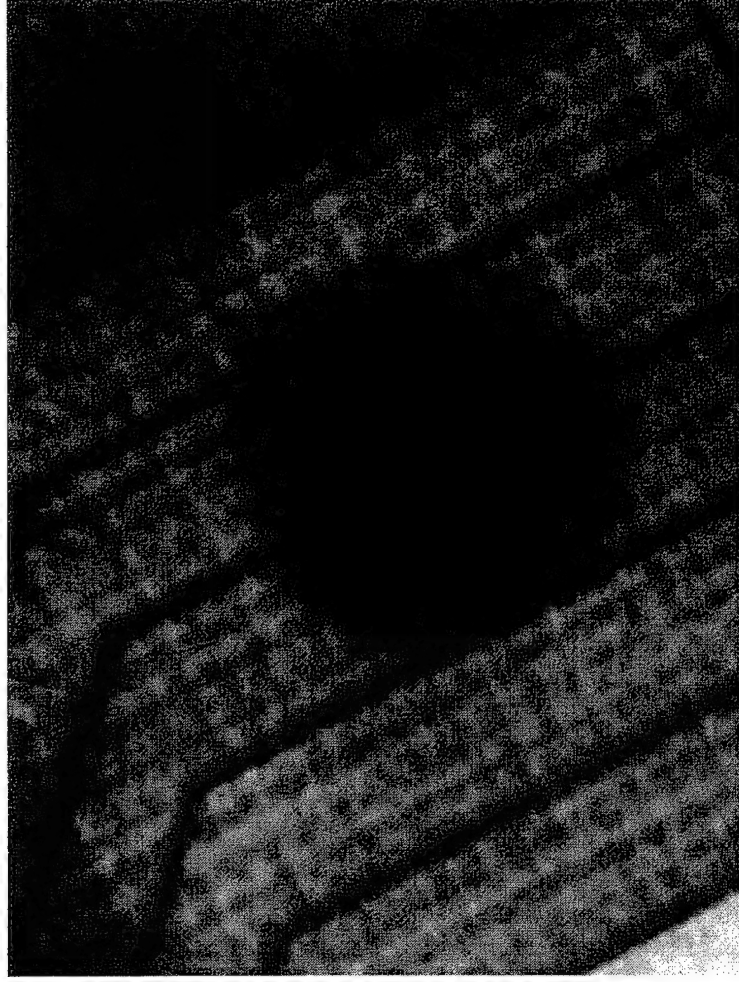
- Data Evaluation:
 - Reverse Voltage.
 - “An unexpected voltage present at the TI test points that is fed back into the 5700A/AN when it is connected to the TI.”
 - Reverse voltages of less than 3 volt may be enough to damage the 5700A/AN.
 - All seven 5700A/AN’s had damaged mother boards
 - an indicator of failure due to reverse voltage.

Damaged motherboard trace caused by "Reverse Voltage" being applied to the 5700A/AN.

- Corrective Action:
 - Developed guidelines using 5700A/AN's in ICPs
 - Ensuring test points are de-energized.
 - Safeguarding the 5700A/AN when making/breaking connections.
 - Ensuring the step sequence is logical.
 - Ensuring appropriate WARNINGS and CAUTIONS are used and properly placed in the ICP.
 - Ensure the 5700A/AN is the appropriate standard to use.
